## Physical Description

### Summary of Character Defining Features

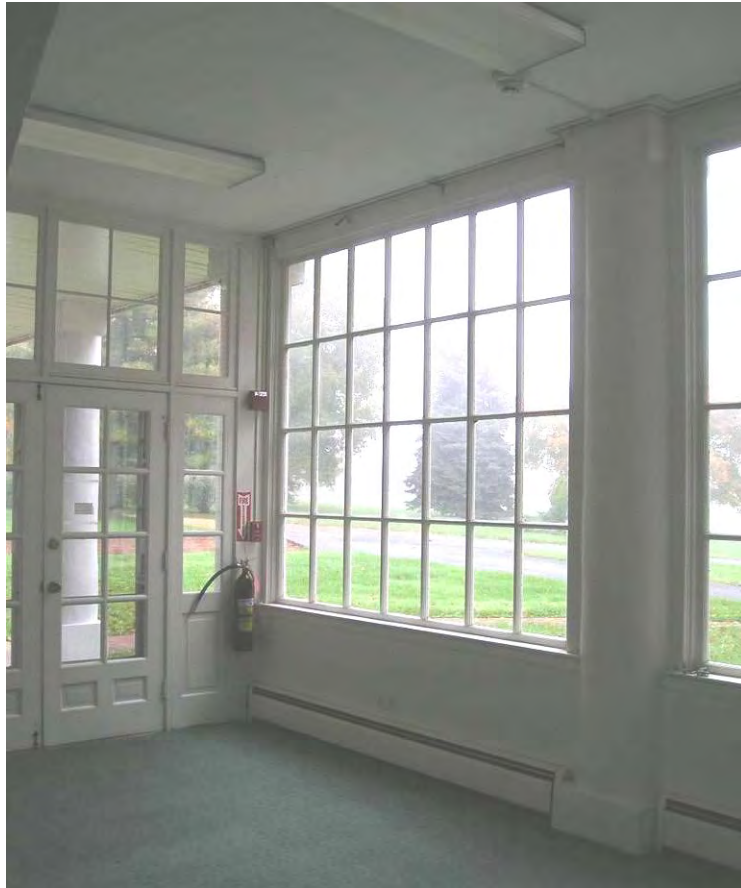
**Fig. 4-104:** Damage to the ceiling. (GWWO photo, 2005.)

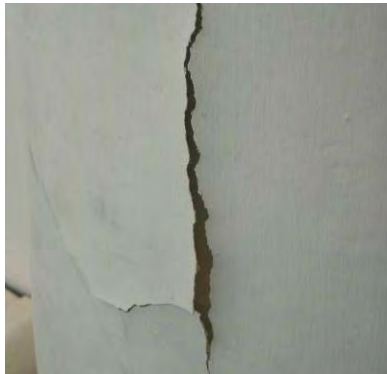
**Fig. 4-107:** Column paint peeling. (GWWO photo, 2005.)

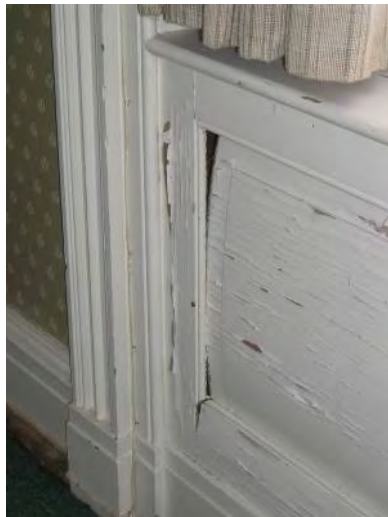
**Fig. 4-184:** Damage at lower window panel, window 39. (GWWO photo, 2005.)

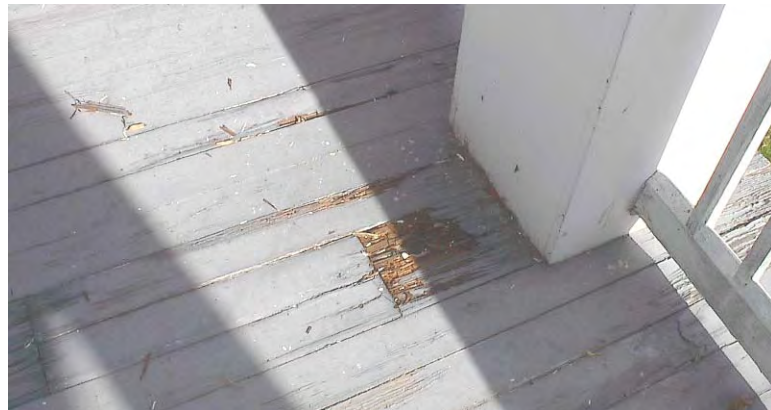
**Fig. 4-234:** At right: water damage at porch deck, space 207. (GWWO photo, 2005.)

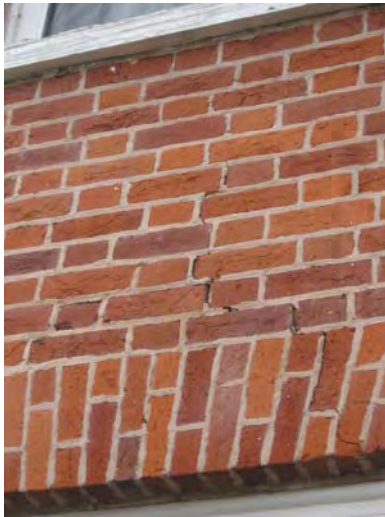
**Fig. 5-005:** Cracks in masonry over window 10, west block, west elevation. (GWWO photo, 2005.)

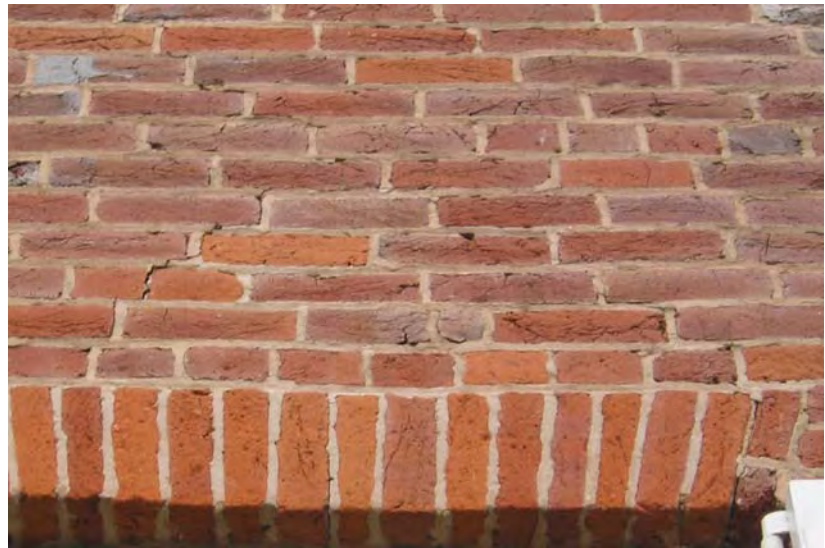
A cracked area is located at the west end of the north elevation, between the first and second story windows (below window 36 and above window 11, Fig. 5-006). Cracks located in this region actually shear bricks in several locations. This condition may be the result of problems discussed above on the west elevation. Alternatively, the problem may be due to settlement of the corner of building.

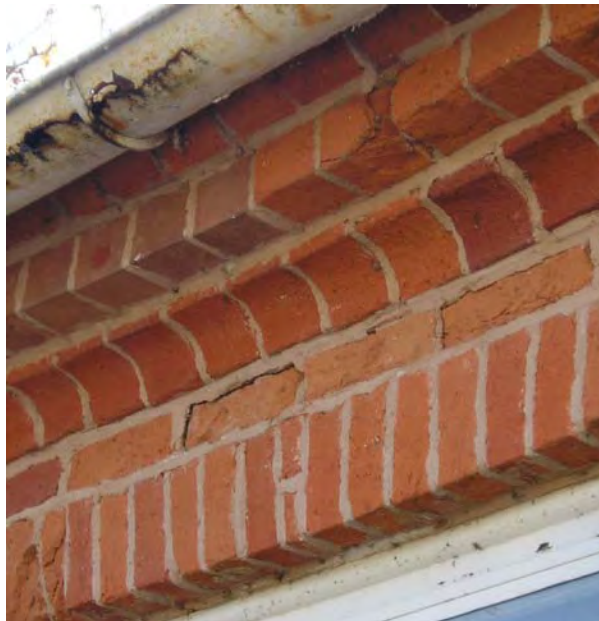
**Fig. 5-008:** Right: Masonry stretcher course above jack arch over window 51, west block, east elevation, second floor. Two bricks have lost the entirety of their surface, and are disintegrating. (GWWO photo, 2005.)

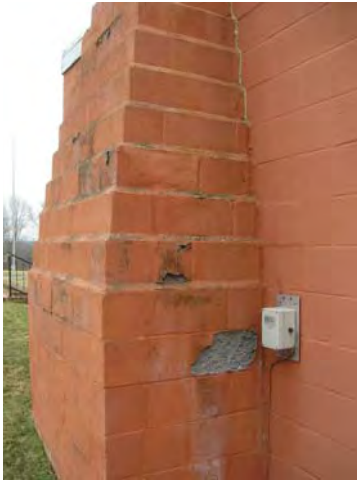
**Fig. 5-010:** CMU masonry at east elevation of northeast addition . The corbelled block surrounds the fire chamber of the fireplace located on the inside. Block surfaces have exfoliated and spalled, probably due to their inability to withstand the heat generated in the fireplace. (GWWO photo, 2005.)

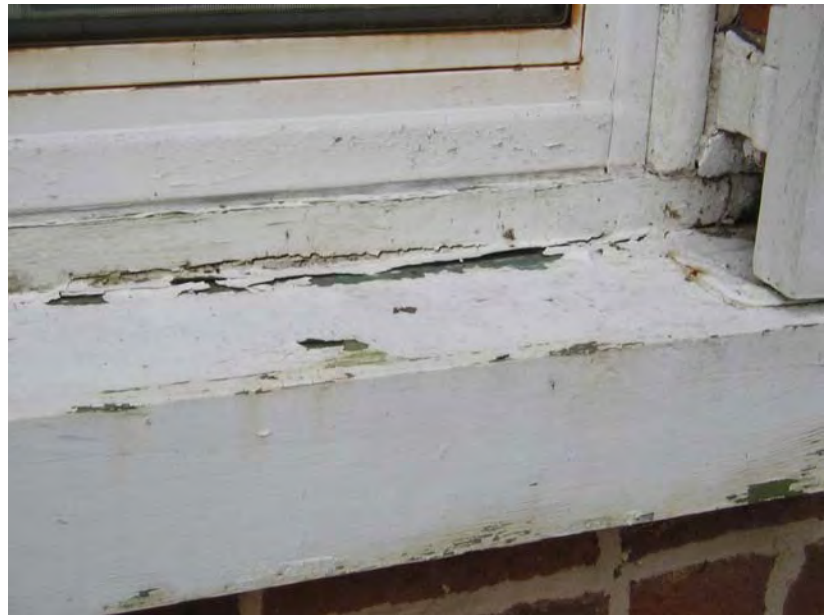
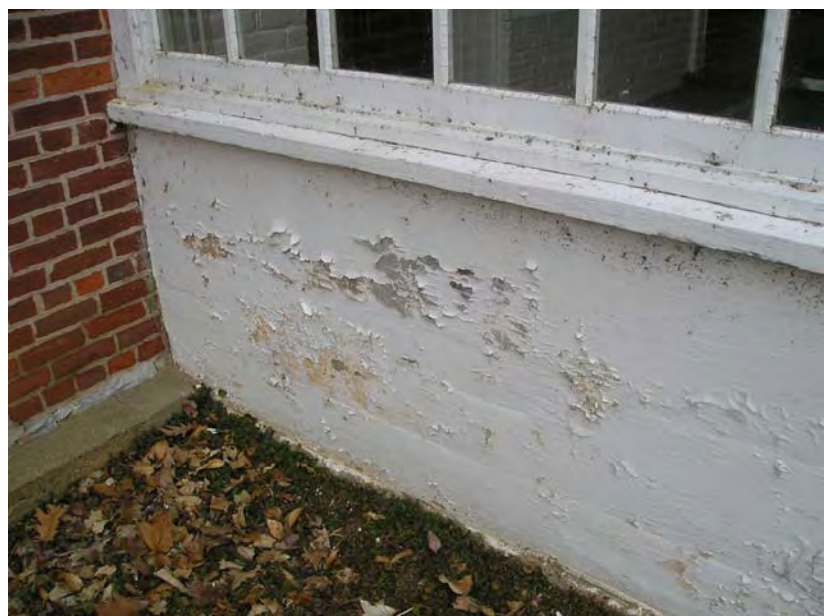
**Fig. 5-011:** Examples of paint failure. Top: window 29, east elevation, west block, first floor. Paint is exfoliating from sill and portions of window casing. Bottom: painted concrete base below glazing of Entry 106, south elevation, north leg. (GWWO photo, 2005.)

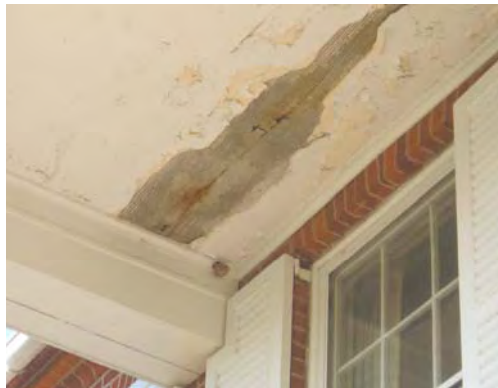
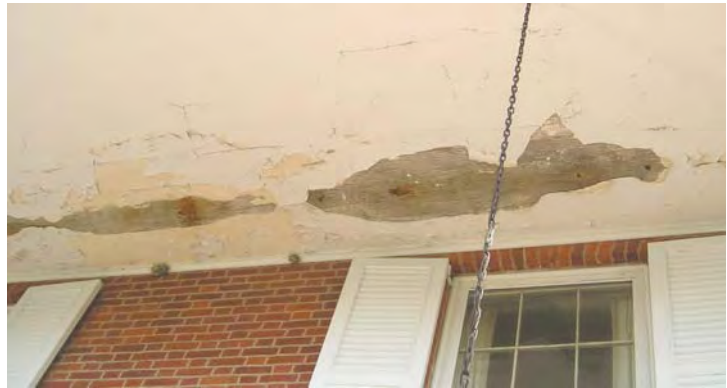
**Fig. 5-013:** Two views of deteriorated plaster ceiling at west porch. Water damage has been caused by failure in the roof. (GWWO photo, 2005.)

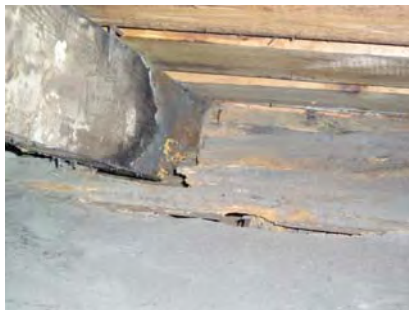
**Fig. 5-015:** Roof rafter and deck deterioration caused by water infiltration at the eave line. (GWWO photo, 2005.)

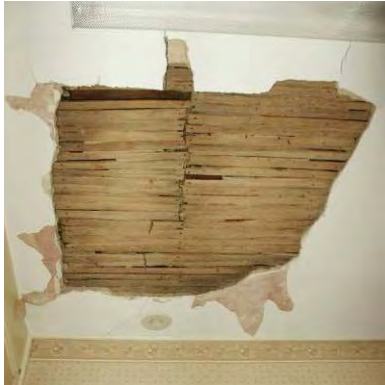
**Fig. 5-018:** Room 107, ceiling above window 26, showing area of missing plaster. (GWWO photo, 2005.)

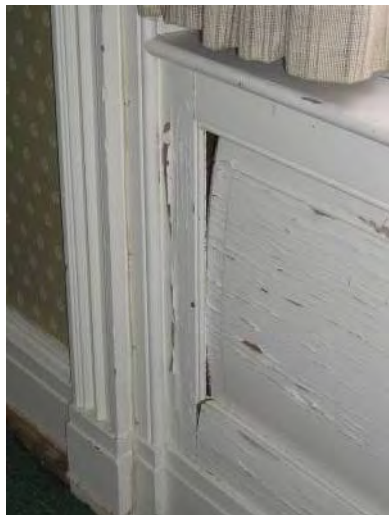
**Fig. 5-020:** Room 205, north wall, under window 39, showing warped wood panel probably due to moisture infiltration. (GWWO photo, 2005.)

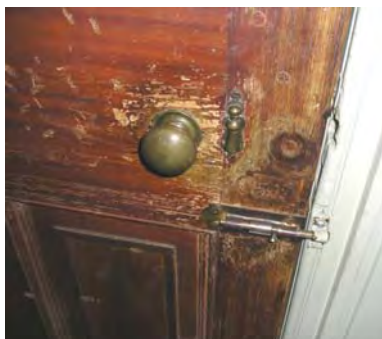
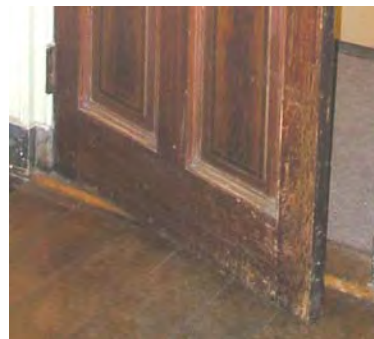
Several of the faux-grained wood doors display damage beyond normal wear and should be conserved. Door 7, Fig. 5-022, at the head of the basement stairs, has considerable wear and loss of finish

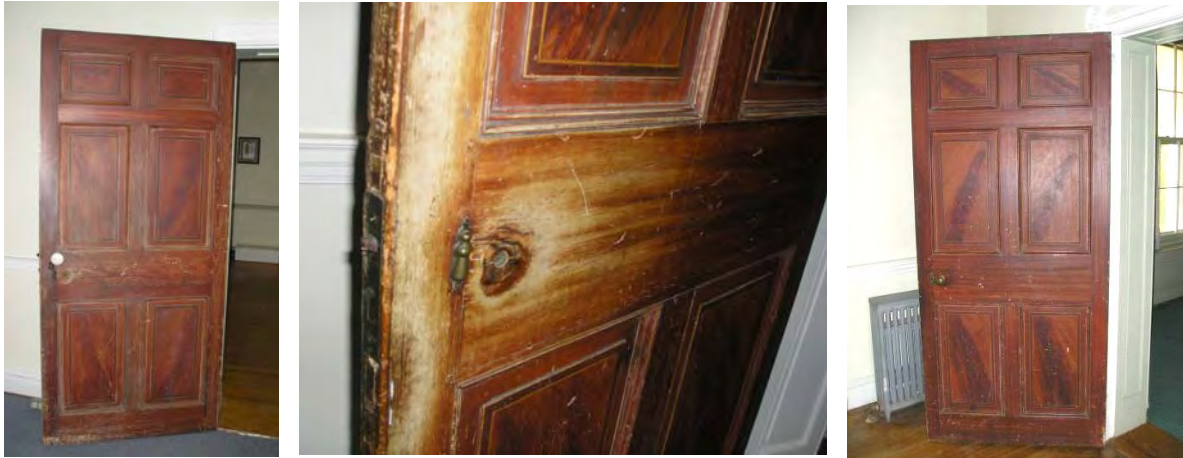
**Fig. 5-023:** Left to right: A) Door 8 to Room 104, has scratching on the hall side; B) Door 9 between Rooms 104 and 105 has excessive wear at the zone of the hardware; and C) Door 28 to Room 201 has scratches on the hall side. (GWWO photo, 2005.)

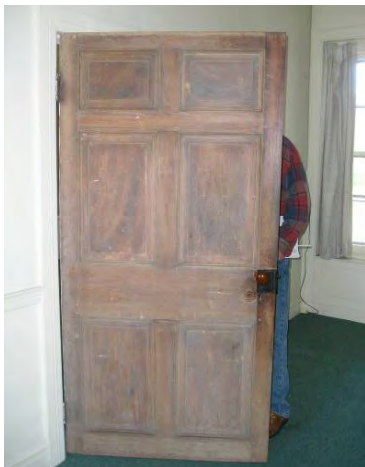
**Fig. 5-024:** Door 28, between Rooms 206 and 208, showing wear from exterior exposure. (GWWO photo, 2005.)

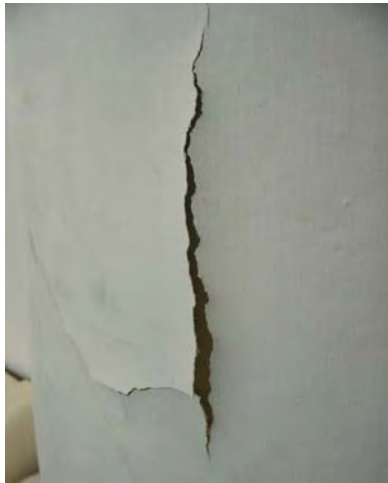
**Fig. 5-026:** Parged column located between windows 27 and 28, Entry 106, showing peeling paint from the parging, due to moisture exposure. (GWWO photo, 2005.)

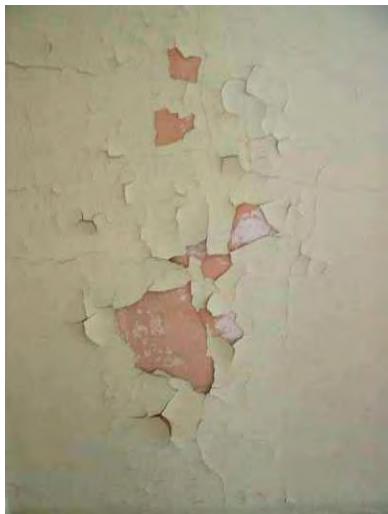
**Fig. 5-028:** Room 204, large patch of paint peeling. (GWWO photo, 2005.)
