CULTURAL LANDSCAPE REPORT

CHESAPEAKE & OHIO CANAL

WILLIAMSPORT, MARYLAND

MILEPOST 98.96 – 99.85

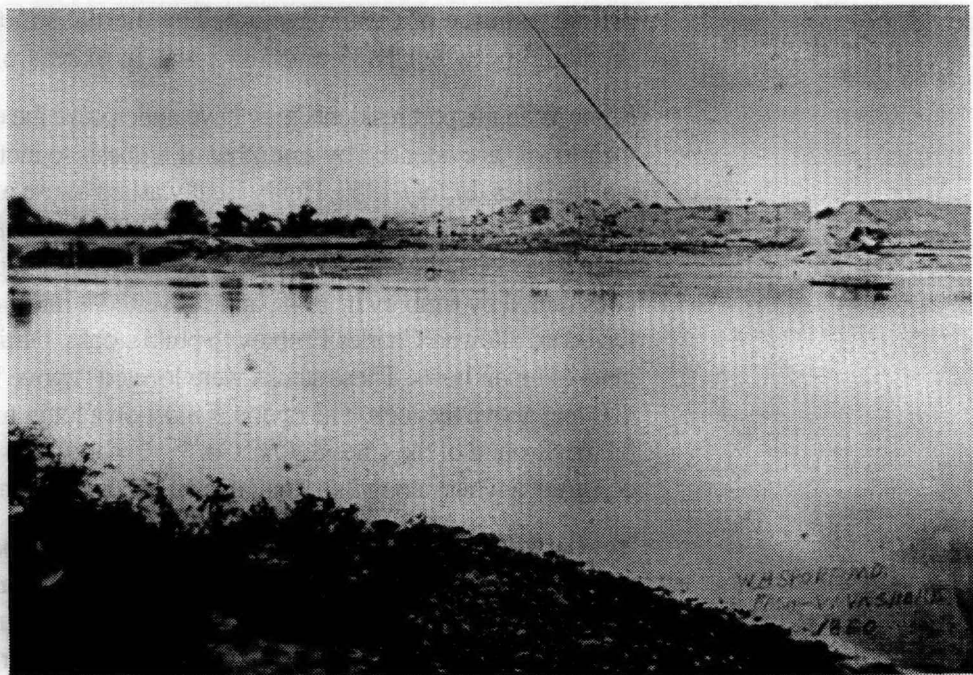
Figure 9. Ferry Crossing at Williamsport, circa 1860. (Chesapeake and Ohio Canal National Historical Park Photo Library)

An early 1860s' photograph best represents this period. Buildings include a wooden house and outbuilding, perhaps a small warehouse, near the ferry crossing. Aside from this photograph, nothing is known about these structures. Only the original warehouse appears near the Cushwa loading basin; other buildings in this vicinity are presumed to have been destroyed early in the Civil War. Piles of coal await loading outside the warehouse.⁶⁶

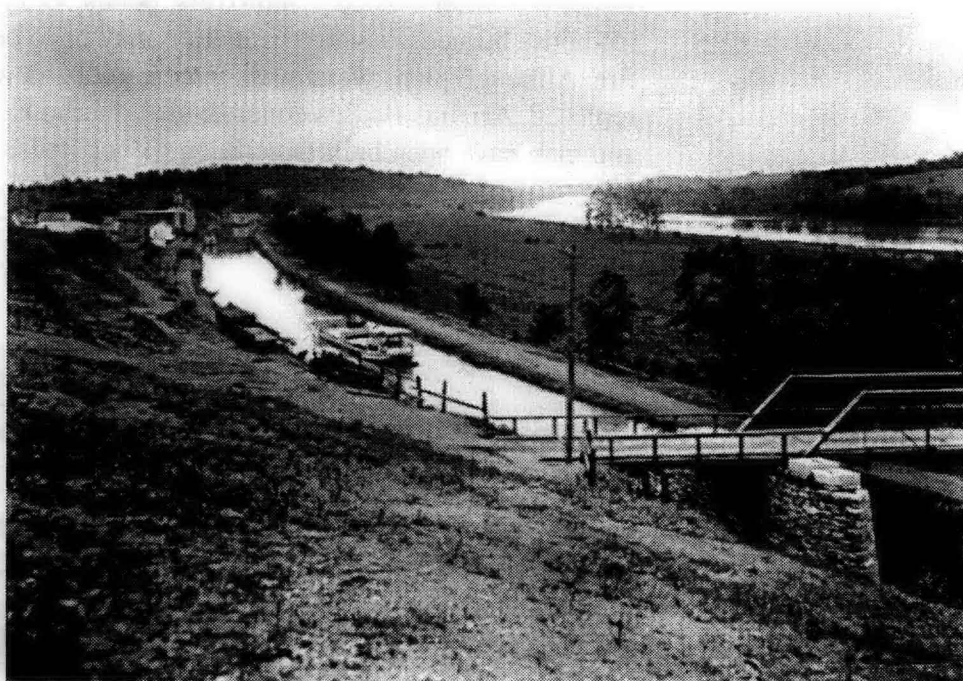
Figure 16. C&O Canal, Williamsport, showing Bollman Bridge in foreground, Steffey and Findlay Lumber Mill and associated buildings in background, circa 1900. (Robert G. Merrick Collection, Maryland State Archives, Annapolis, Maryland)

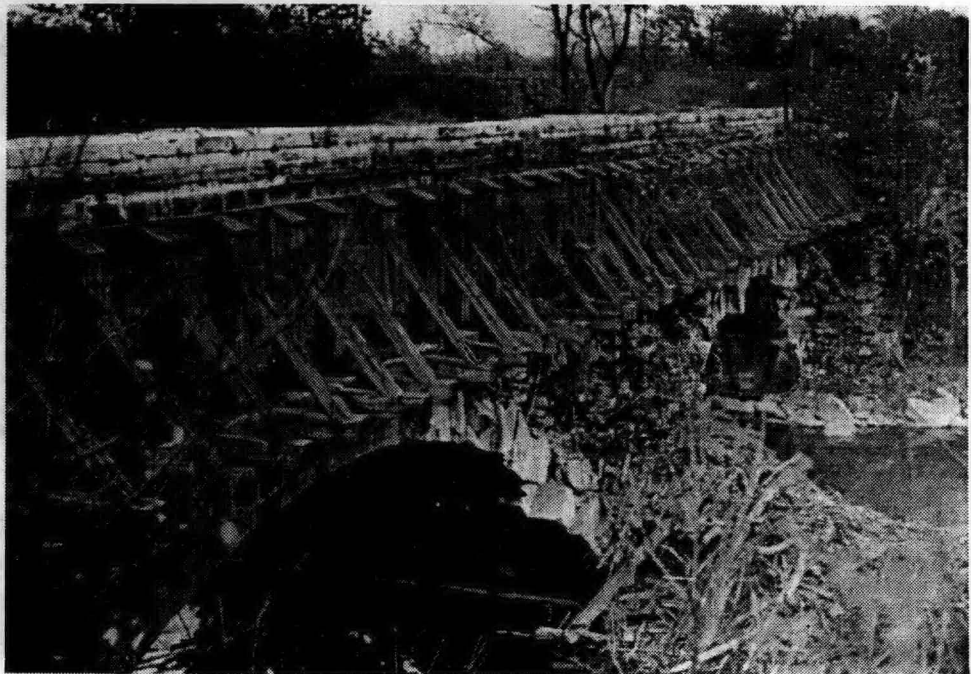
Figure 18. Berm side of the Conococheague Aqueduct with wood parapet, circa 1939. (Chesapeake and Ohio Canal National Historical Park Photo Library)

The wooden parapet was dismantled completely some time after the canal ceased operation.
