## Physical Description

### Summary of Character Defining Features

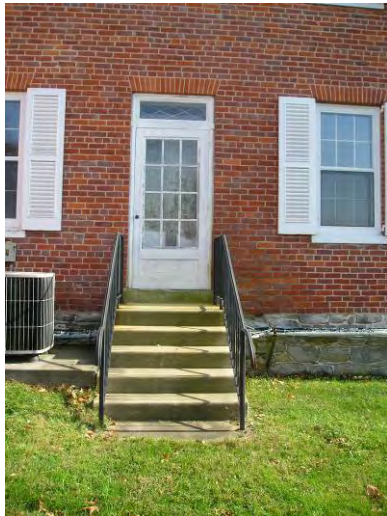
**Fig. 4-034:** North elevation, north leg, Door 15. (GWWO photo, 2004.)

A door (Fig. 4-034) from the dining room is located in the sixth bay in from the west corner, centered under the second floor window. The 6-panel wood door (Period One, described with the interior) is protected by a wood and glass storm door (Period Four?) with 12-lights of glazing above a single lower wood kick-plate panel. The door is headed with a fixed, rectangular transom panel (Period One, described in the interior) that is protected on the exterior with a single storm panel (Period Four). The head of the transom light aligns horizontally with the heads of the adjacent windows. A concrete landing and five concrete steps (Period Four) lead from the door to the adjacent grade.

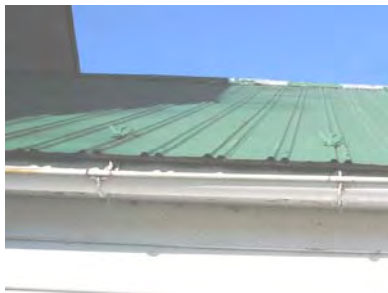
**Fig. 4-035:** South and east elevations of the east addition. To the right (north) of this addition, portions of the subsequent northeast (cmu) bar addition are visible. (right). Detail of double-ribbed metal roofing (above). (GWWO photo, 2005.)

The gable roof is clad in standing, double-ribbed metal (Period Five), painted green. Double-ribbed metal is similar to standing seam, although there are two adjacent seams (Fig. 4-035). The pitch of the roof (8.5 in 12) is steeper than that found on the main house (6.5 in 12). Double ribs are located approximately every 8". A line of snow-guards is located approximately 1' above the eave line; guards are mounted on every fourth rib. On the south elevation, a half-round painted metal gutter slopes to the west, and terminates at a painted round downspout mounted on the adjacent masonry wall of the south porch.

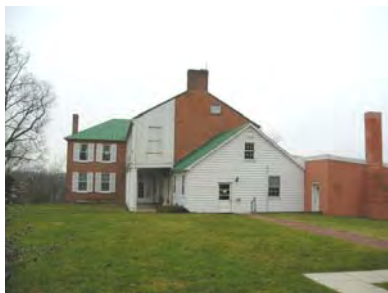
A one-and-one-half story wood-framed, east addition (Period Three, Fig. 4-035) is attached to the easternmost portion of the north leg. The plan dimensions of the addition are approximately twenty feet wide by twenty-four feet deep. The south wall of the addition aligns with the plane of the masonry under the south porch (Fig. 4-036).

**Fig. 4-036:** East Elevation showing east addition. To the left (south) of the addition, the east elevation of the north leg and the east elevation of the west block are both visible. To the right (north) of the addition, a segment of the later northeast (cmu) addition is visible. (GWWO photo, 2005.)

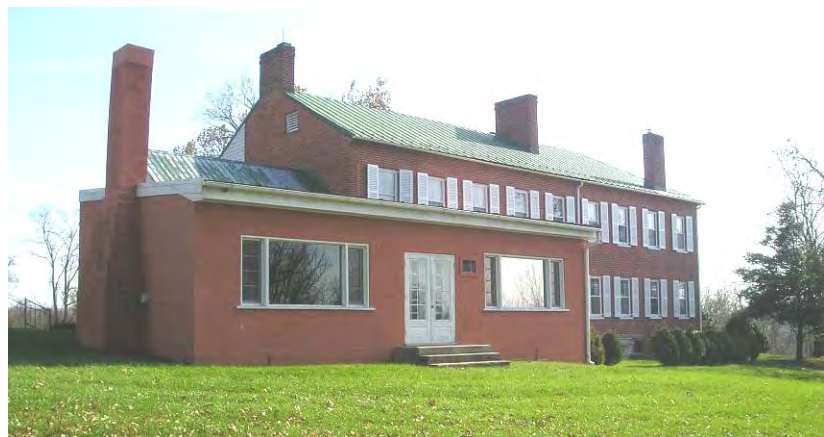
**Fig. 4-037:** Northeast (Bar) addition. (GWWO photo, 2005.)

The most recent addition to the property is a one-story rectangular volume located north of the east kitchen addition (Fig. 4-037). The outside footprint is approximately 20'-6" by 39'-6".

The exterior of the northeast addition is constructed of 8" high by 16" wide concrete masonry units (cmu), currently painted a reddish-brown (Period Four or Five). Openings in the wall are spanned with steel lintels; no special masonry treatment is used above the heads of openings. A cmu chimney is centered on the east elevation (Fig. 4-037, detail Fig. 5-010.).

On the north elevation, a central opening with a pair of stile-and-rail "French doors" is flanked on either side by "picture" windows (Fig. 4-037). The masonry opening for each window is 4'-8" tall and 10'-5½" wide. The windows are tri-partite units: a central light approximately 4' high by 5' long is flanked on each side by a narrow vertical casement unit divided into four lights. The side casements are operable.

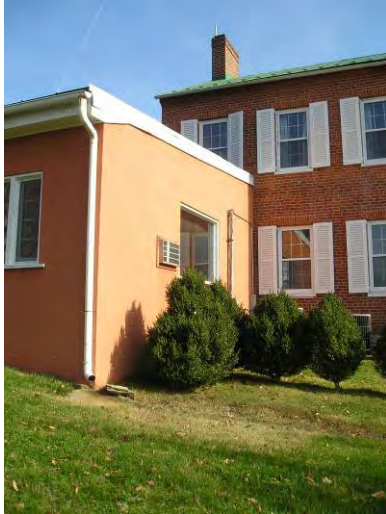
**Fig. 4-038:** Northeast Bar addition showing the attachment to the eastern-most end of the north leg. (GWWO photo, 2005.)

The shallow-sloped roof (Period Five) is a standing seamed metal (detail Fig. 5-003), surface coated with asphalt, sloping down from south to north. Seams are approximately 1' apart. The north side of the roof has a boxed wooden eave (Period Four, Fig. 4-038) projecting out from the plane of the north wall by approximately one foot. A painted metal half-round gutter is mounted to the eave, and slopes to a round, painted metal downspout mounted at the west edge of the north wall. The downspout discharges to grade. The east and west sides of the roof are trimmed with flat wood fascia boards, painted the trim color.

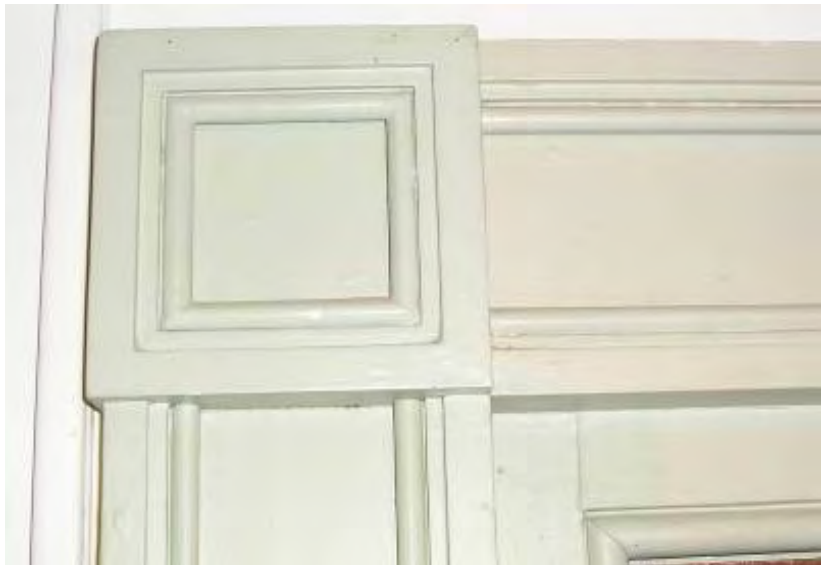
**Fig. 4-061:** Door 4, (GWWO photo, 2005.)

The wood door (Period One), with six raised panels (Fig 4-061), has a faux graining to imitate mahogany with a cherry inlay banding. Two five-knuckle brass hinges secure the door to the frame casing.

*Door 4:* The casing and graining (Period One) for this side of the door are identical to that found on the room 101 side. This side of the door has the (Period One) brass knob and key hole cover.

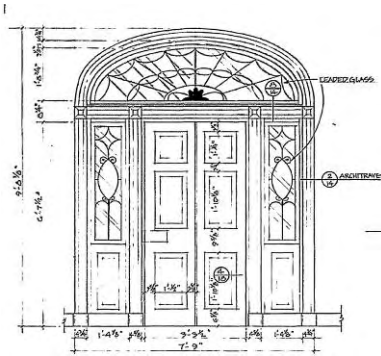
Fig. 4-069: Door 5, Room 103.

*Door 5:* This large door (Period One) serves as the formal main entrance to the house. This 4' wide, six panel wood door has a vertical central bead running its entire height creating the appearance of two side-hinged doors (Fig 4-069). The inside face of the door is faux-grained matching the other doors in the house. There is an existing, brass, surface-mounted box lock (Period One), with a surface mounted keeper aligned on the adjacent jamb casing. There is a key-hole in the box lock as well as a brass doorknob (Fig 4-070). Two side lites and a large glass transom flank this main door. The trim around the door, side lites and transom is all painted green to match the trim in the room, and the trim (Period One) profile on this door is identical to the door trim in room 101.

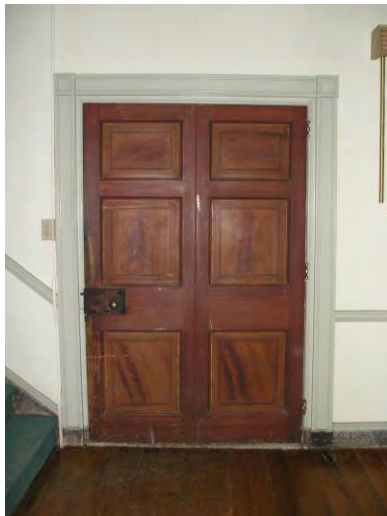
Fig. 4-071: Door 6, (GWWO photo, 2005.)

*Door 6:* The trim and casing of this door (Period One) are identical to the door trim in room 101, but the inner casing is painted white instead of green. This 4' wide, six panel wood door (Period One) has a vertical central bead running its entire height that makes the door appear as if it were two, side-hinged doors (Fig 4-071). The hall side of the door is faux-grained, with significant scratches in the lower portion. Three five-knuckle hinges secure the door; although the center hinge pin is missing. There is a surface mounted brass box lock (Period One), approximately 6" x 9" x 1.5" with a brass knob. There is a large 18" limestone threshold (Period One).

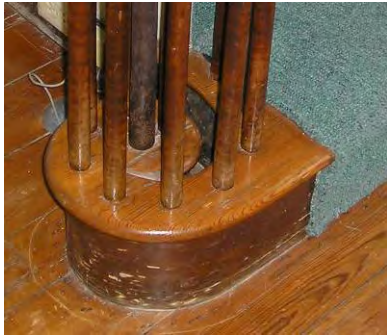
**Fig. 4-077:** Lateral scroll terminus at lowest stair tread. (GWWO photo, 2005.)

*Treads and Risers:* The treads and risers (Period One) are carpeted (Period Five) from the wall up to the line of the balusters. The stained wood risers and treads are visible beyond the carpet (Fig. 4-077). The lowest stained tread and riser follow the lateral scroll of the handrail above, and transitions rather seamlessly into the faux marble base of the entry hall 103.

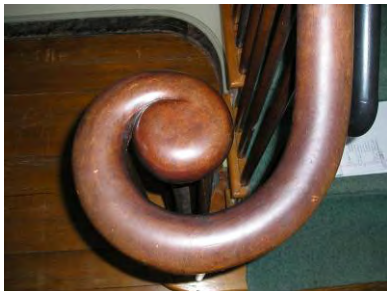
**Fig. 4-078:** Lateral scroll handrail terminus. (GWWO photo, 2005.)

*Railing:* The stained wood hand rail (Period One), which is turned and carved, has a 2-1/4" diameter cross-section. The railing begins at the base of the steps in a lateral scroll (Fig. 4-078) and is supported by simple round balusters (three to a tread) that taper slightly, from about 7/8" at the top to 1" at the bottom.

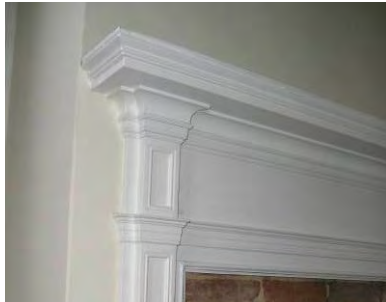
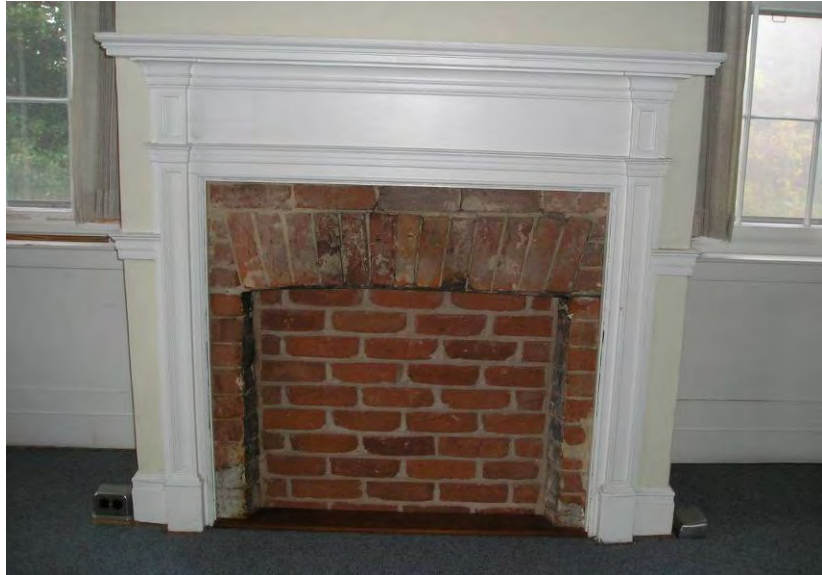
**Fig. 4-083:** Mantle shelf and upper pilaster (above), and overall fireplace (right). (GWWO photo, 2005.)

The exposed brick surround and jack arch (Period One, cleaned and repaired Period Four, Fig. 4-083). This fireplace has been filled in with horizontally laid brick (Period Four or Five). Any projecting hearth is not visible, as the area has been covered by the room carpeting.

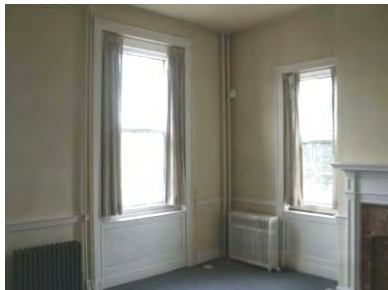
**Fig. 4-089:** Windows, room 104. (GWWO photo, 2005.)

*Windows 11 and 12:* (Period One with modifications through Period Five) These two windows are not as tall (5' 11") as windows 9 and 10, but the base plinths and sill height (2' 3") are the same. (Fig 4-089). The casing reaches from the base board to the head of the window. The windows are six over six double-hung windows with rope pulleys and narrow muntins.

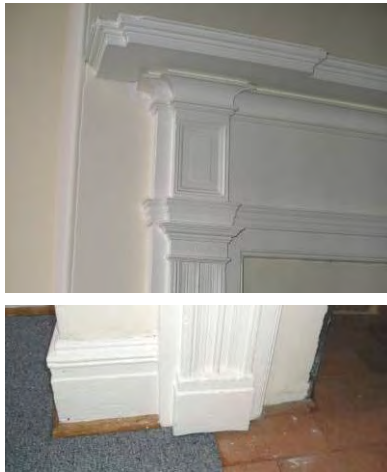
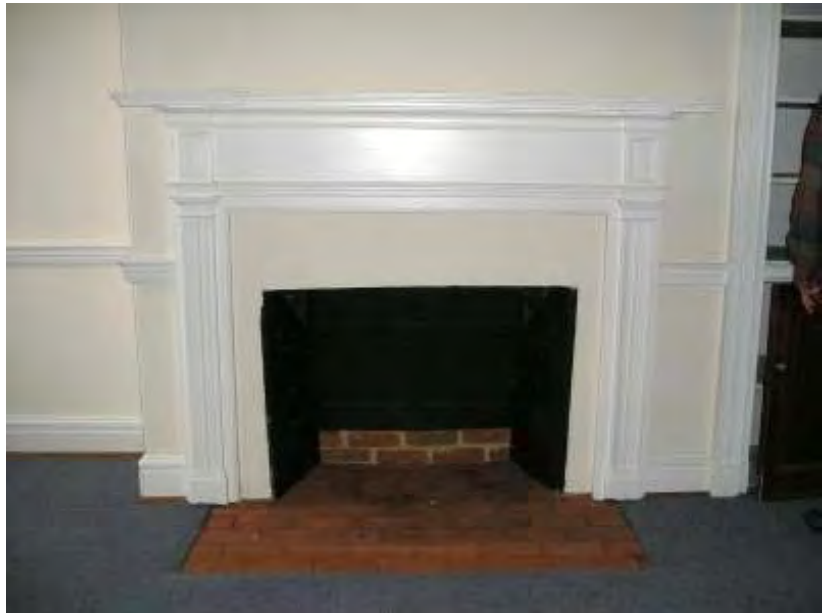
**Fig. 4-095:** Mantle shelf and upper pilaster (top left); Fireplace overview (right); Lower pilaster and hearth (bottom left). (GWWO photo, 2005.)

*Fireplace:* There is a fireplace on the east wall of the room (Fig. 4-095). The north edge of the mantle shelf is flush with the edge of the fireplace projection, whereas the south edge terminates several inches before the beginning of the recessed cupboards in this room. The white painted wood mantle (Period One) is somewhat similar to the one found in room 104. The mantle shelf (Fig 4-096) has several stair-stepped fillet edges, some with beads, and there is a large projected area above each of the pilasters. A tall cavetto trim with a lower fillet and beaded edge appears to support the shelf. This trim continues across each of the projecting pilasters.

replaced, possibly during Period Four or Five (Fig. 4-095). The hearth (Period Four or Five) is brick, dry laid in a plain running bond set parallel to the fireplace.

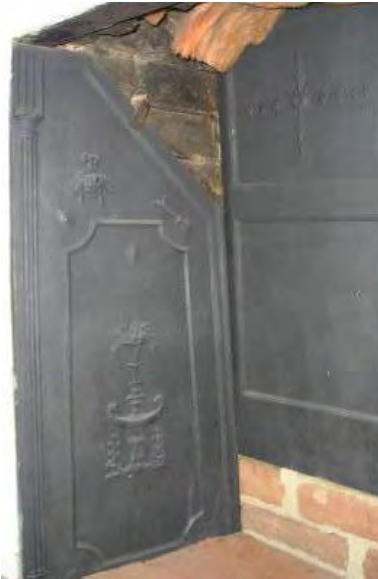
The remainder of the surround is simple plain wood with a beaded trim around the opening. Inside the firebox, a cast metal fireback, with side plates (Period Unknown, Fig. 4-099) covers most of the masonry. The side panels are embossed with an image of a fountain and flowers. At the upper back corner of either side of the firebox, there are Period One firebricks visible (Fig. 4-099). On the back wall of the firebox, below the fireback, the firebrick has been cleaned and

**Fig. 4-099:** Rm. 105 fireplace insert. (GWWO photo, 2005.)

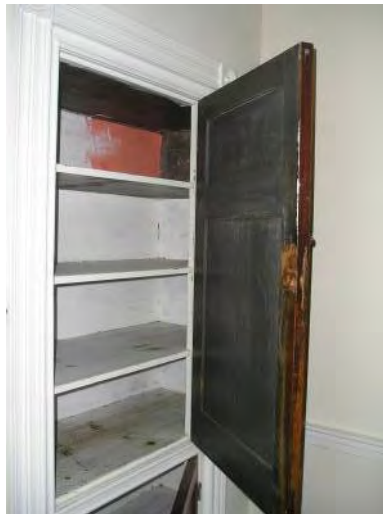
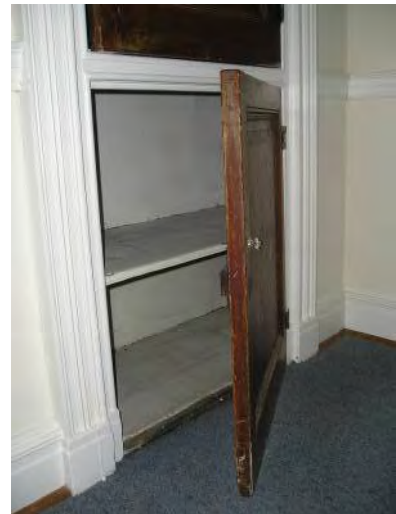
*Cabinets:* There is a built-in cupboard (Period One) in the east wall to the south of the fireplace (Fig. 4-100), filling the alcove left by the fireplace projection. The cupboard is made up of a taller upper cupboard with a two-panel door and a smaller lower cupboard with a single panel door. The trim around the overall cupboard matches the door and window trim of the room, and is also painted white. The outside of the doors of the cupboards are grained in the faux inlay pattern seen throughout the house, and there is a white painted strip of trim between the two cupboards at the height of the chair rail.

**Fig. 4-100:** Rm. 105 Upper Cabinet (L) and Lower Cabinet (R). (GWWO photo, 2005.)

The cupboard doors show evidence of earlier hardware. The inside of the upper cupboard door has staining that indicates there may have been a box lock with a key opening on the front. The cupboard casing has a recess where the keeper for the lock would have fallen. Currently, there is only a small glass pull (Period Unknown). The lower panel has the original metal box lock mounted on the inside. The door is falling off its hinges. Each door has two small three-knuckle hinges with drop pins from the top.

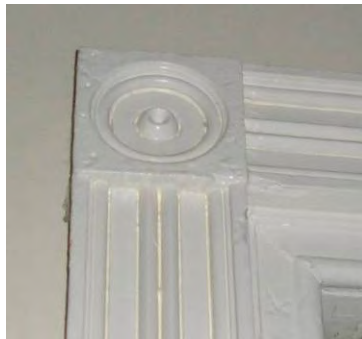
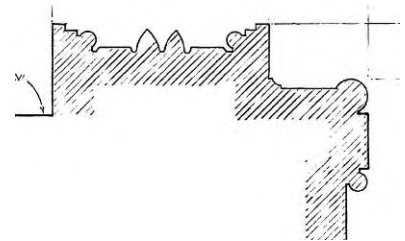
**Fig. 4-101:** Room 105 door and window trim and cornerblocks (L). GWWO photo, 2005. (GWWO photo, 2005.)

*Door 9:* The upper corner blocks of the door casing (Period One) are square with a double beaded circular inset area with a central circular molding that is similar to the bullet-shaped projections found in other rooms, but here with the center hollowed out (Fig 4-101). The running trim at the head and jambs (Fig. 4-101) has a symmetrical cross-sectional design that starts at the outer edges with a fillet and steps down and inward to a quirked bead. Moving inward, narrow raised fascias meet two bullet-shaped linear projections at the center. The inner casing of this door is painted white. On this side of the room, the door (Period One) is also faux-grained. There is significant wear in the location where the hardware once was, and only the decorative key-hole cover (Period One) remains. This upper hinge is not working well, and the door does not shut properly.

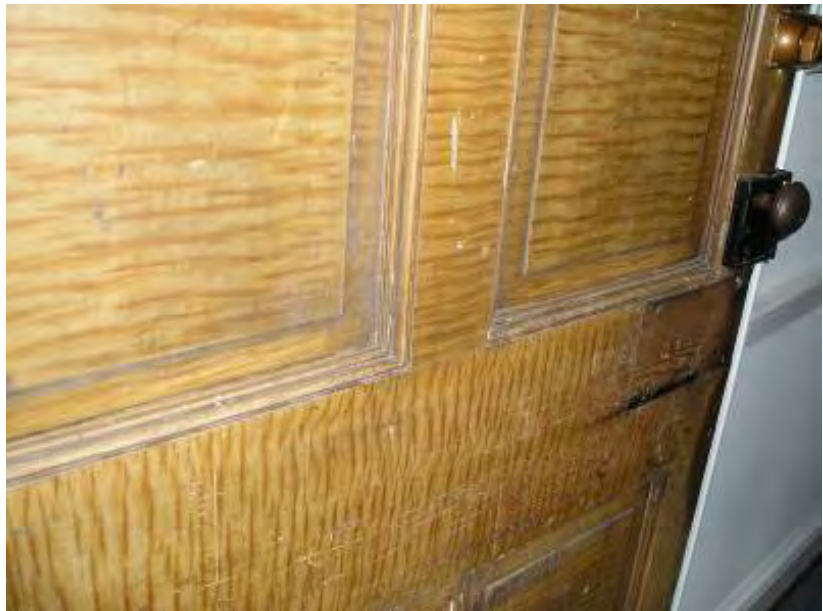
**Fig. 4-102:** Room 105, door 10, showing detail of bird's eye tiger maple painted graining. The reason for the change in graining style from the rest of the house, is unknown. (GWWO photo, 2005.)

*Door 10:* This door (Period One) has the same trim as door 9, but the door itself is quite different. The room 105 side of this door is faux-grained in a bird's-eye tiger maple (Fig. 4-102), as opposed to the typical mahogany-cherry inlaid design. The reason for the change in graining style on this door is unknown.

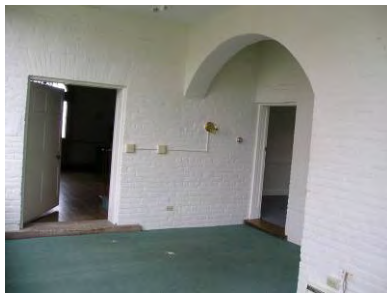
**Fig. 4-105:** View looking northeast and the archway to the alcove. (GWWO photo, 2005.)

*Wall:* The north and west walls (Period One) were originally exterior walls of the house, and have been painted white (Period Two through Five). The west portion of the north wall has a large brick archway (Fig. 4-105) that leads into a brick alcove outside of doors 10 and 12. While the alcove is original to the house (Period One) the archway has been significantly modified (Period Three or Four) and it is unknown how this area was originally finished. The eastern portion of the north wall shows evidence of where a Period One window was removed and the opening filled in with masonry during Period Four (Fig. 4-106). The east wall (Period Four) is entirely made up of Door 13 and its surrounding windows (Fig. 4-103). The

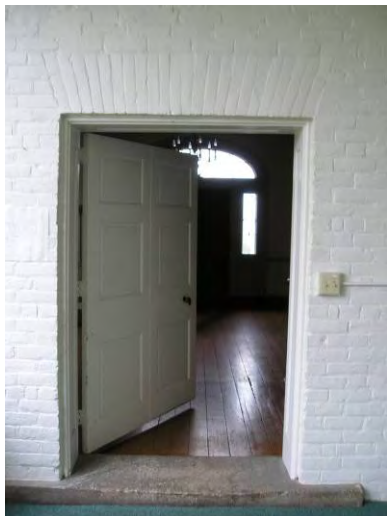
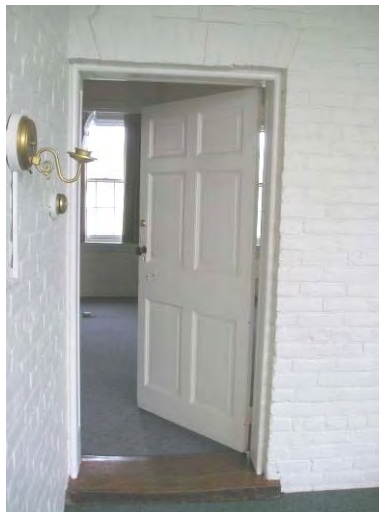
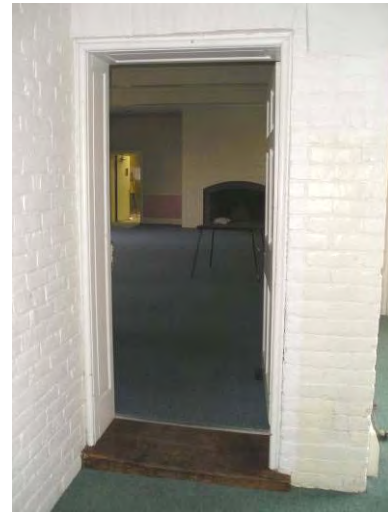
**Fig. 4-108:** Door 6 (above), 10 (center) and 12 (right). (GWWO photo, 2005.)

*Door 6:* This 4' wide door (Period One, Fig. 4-108) is painted white and was originally an exterior door. The inner casing is 5" deep and has the typical inset panels. On this edge face of the casing panel, there is a large 7/8" bullnose trim (Period One) that transitions the casing to the outer brick. The jack arch above this door is made up of bricks, laid in an alternating soldier and header arrangement. There is an 18" limestone threshold (Period One) into room 103.

*Door 10:* Door 10 (Period One, Fig. 4-108) is painted white, and was originally an exterior door. The inner casing is 3 7/8" deep and has the typical inset panels. On this edge face of the casing panel, there is a large 1 3/8" bullnose trim (Period One) that transitions the casing to the outer brick. The jack arch above this door is a single course bricks. There is a 14" wood threshold (Period One) into room 105.

*Door 12:* Door 12 (Period One, Fig. 4-108) is painted white, and was originally an exterior door. The inner casing is 7 1/4" deep and has the typical inset panels. On this edge face of the casing panel, there is a large 1 1/2" bullnose trim (Period One) that transitions the casing to the outer brick. The jack arch above this door is a single

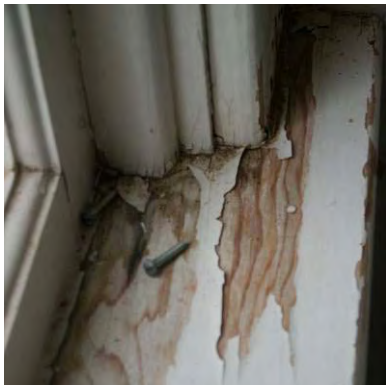
South Wall (Fig. 4-103) is made up of Windows 27 and 28 above a low painted concrete base (Period Four), set in between the masonry columns (Period One) covered with parging (Period Two). There is some damage to the columns where the paint is peeling away.

**Fig. 4-113:** Windows 27 and 28 sill and trim paint peeling. (GWWO photo, 2005.)

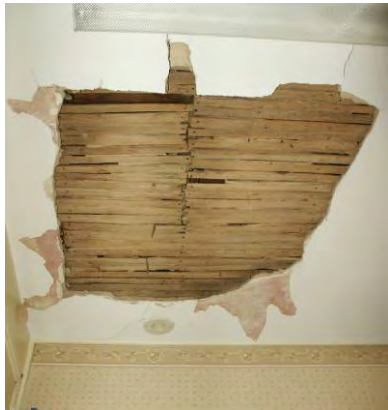
**Fig. 4-115:** Exposed lath to the west of the western beam on the south portion of the ceiling.  
(GWWO photo, 2005.)

**Ceiling:** The plaster ceiling is painted white (Period One, with major modifications in period Four and Five). To the west of the two ceiling beams (see description below) there is a large patch of missing plaster and exposed wood lath (Fig. 4-115). Several areas of ceiling were exposed in order to more fully understand the framing and structure of the beamed area and the part of the ceiling between these two beams (Fig. 4-116). A nail (nail 3) was removed from the ceiling and is discussed in Appendix C.

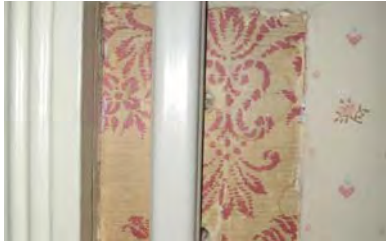
**Fig. 4-117:** Older wallpaper (period unknown) seen below existing paper. (GWWO photo, 2005.)

*Wall:* The walls (Period One with major modifications in Period Four and Five, as indicated) are covered in modern (Period Four) wallpaper. In several places, the modern paper has peeled, revealing a dark tan/scarlet floral paper below (Period unknown, Fig. 4-117).

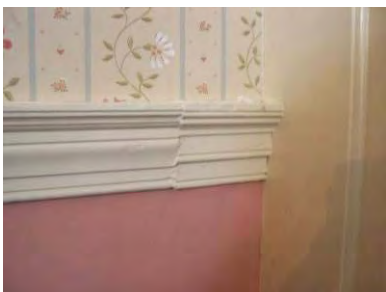
**Fig. 4-120:** Transition from Period Four replacement trim to Period One trim north of the fireplace (above). South wall, below chair rail which shows peeling, cracking and exfoliation (center and right). (GWWO photo, 2005.)

Below the chair rail, the paper has been painted bright pink (Fig. 4-114). There are several patches where the paper is cracking, peeling and exfoliating, particularly on the south wall (Fig. 4-120).

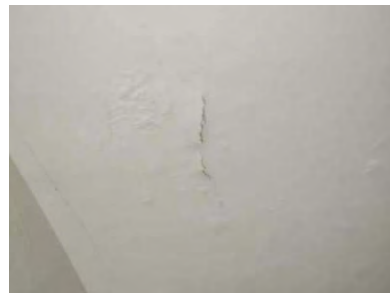
**Fig. 4-142:** Room 115 ceiling damage. (GWWO photo, 2005.)

*Ceiling:* The ceiling is gypsum wall board painted white. There is some water damage and cracking in center of the ceiling. (Fig. 4-142.)

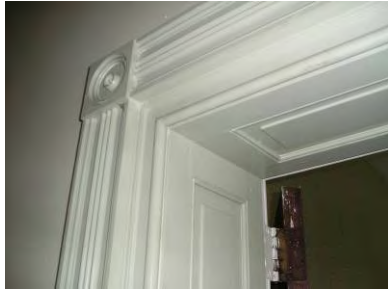
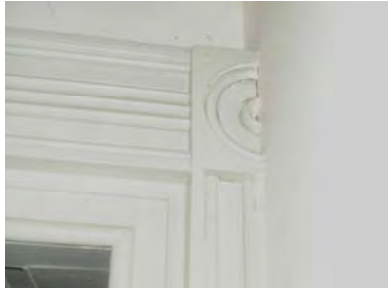
**Fig. 4-164:** Room 202, example of door trim, casing and corner block (above). Door 30, with the eastern corner block and jamb truncated by the east wall of this room (lower). (GWWO photo, 2005.)

*Door 30:* The eastern jamb of the door trim and the cornerblock (Period One) are truncated by the east wall of this room (Fig. 4-164). The hall side of this door has a single brass knob (Period One).

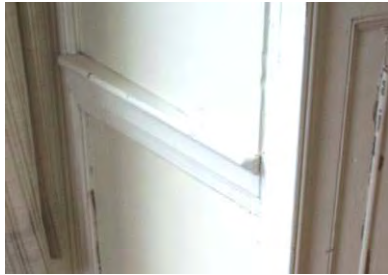
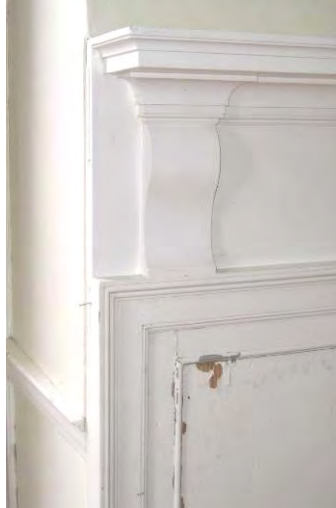
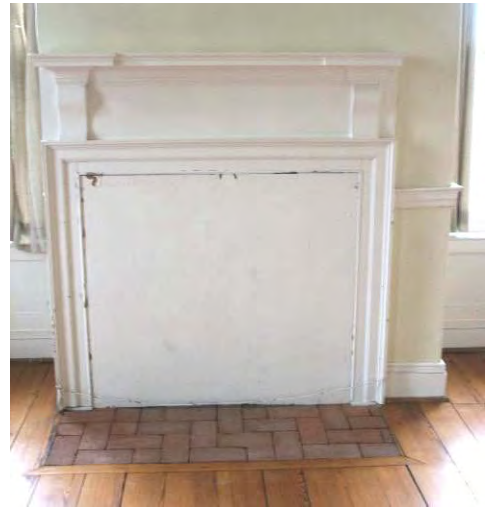
**Fig. 4-171:** Chair rail on north face of chimney projection, which is unevenly installed and has a crudely truncated end (above); detail of mantle shelf and surround (center); overall fireplace (right). (GWWO photo, 2005.)

*Wall:* The flat plaster walls (Period One) are painted cream. The paint is cracked and peeling in the west corner of the north wall. There is also cracking above windows 34, 35 and 36 that extends into the ceiling and onto the chimney. The room has a 3 1/4" wood chair rail (Period One, Fig. 4-169), which is painted white and installed with the upper edge 33 1/2" above the floor. The upper course of the rail has a projecting torus. Below this, there is a fascia with an upper cavetto. A similar profile is repeated immediately below this, though smaller and slightly inset with a lower quirked bead. There is a portion of chair rail on the side of the fireplace that is partially covered with plaster and installed unevenly (Fig. 4-171).

*Fireplace:* The simple fireplace in this room is located on the north wall. The surround is mounted off-center (Fig. 4-171) on the projecting wall/chimney area, with its western edge flush with the edge of the projection, and actually truncated and unfinished in its installation. This arrangement leaves nearly a foot of space on the eastern end of the projection, to accommodate the flu from the first story fireplace below.

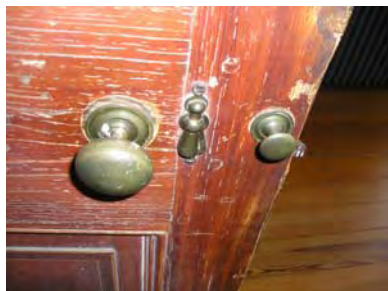
**Fig. 4-174:** Door hardware for door 29. (GWWO photo, 2005.)

*Door 29:* The hall side of the door (Period One) has a single brass knob (Period One) and the decorative key hole and cover (Period One). There is some scratching and wear around the hardware on this door (Fig. 4-174).

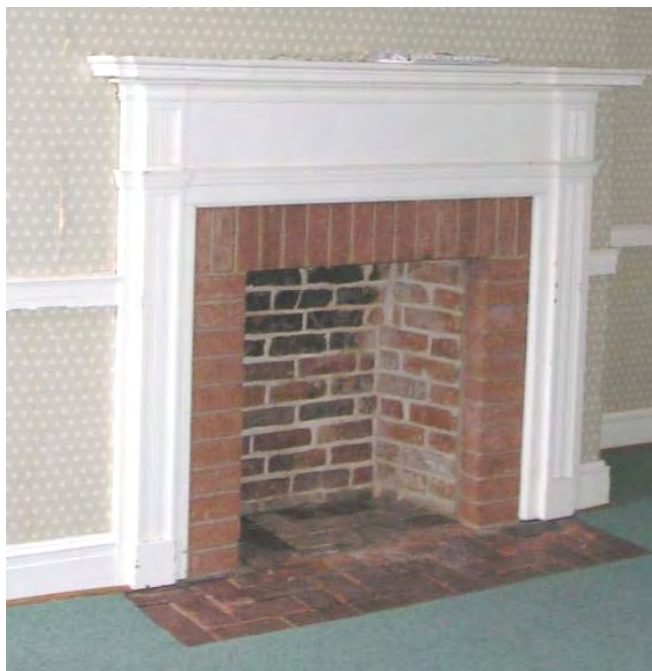
*Fireplace:* The white painted wood fireplace surround (Period One, Fig. 4-182) in this room is similar in design to the one found in room 105. The pilaster frieze design has a center vertical bead strip, as do the lower pilaster designs (Fig. 4-181). This fireplace also has brick on the face of the firebox surround, whereas the 105 fireplace has exposed plaster.

The brick surround has been cleaned and reworked (Period Four or Five, Fig. 4-182). The brick at the head of the firebox is laid in a soldier course, and there is one course of horizontally laid, stacked brick at each side of the face (Period Four).

**Fig. 4-182:** Photograph of fireplace. (GWWO photo, 2005.)

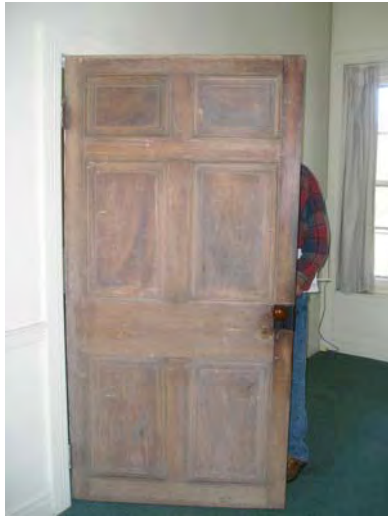
**Door 44:** This opening (Period Two) has a 37"-wide faux-stained (Period One) door that appears to have been relocated from some unknown location in the house. This side of the door is weathered,

**Fig. 4-192:** Door 44, weathered side. (GWWO photo, 2005.)

as if it had been exposed to the elements for some time (Fig. 4-192). The profile of the trim and casing (Period Two, Fig. 4-193) of this door matches the trim in the Period Two bathroom (room 203). The door has a box lock (Period One or Two) with a brown porcelain knob.

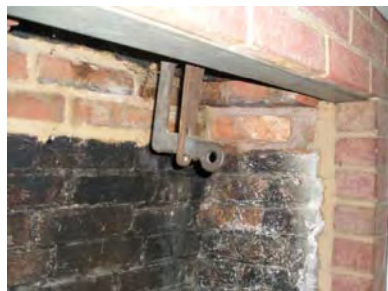
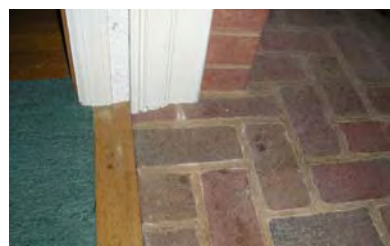
**Fig. 4-205:** Steel lintel and inner firebox stained by carbon (above); outer hearth and transition to the carpeting (below). (GWWO photo, 2005.)

A very simple beaded molding (Fig. 4-204), made up of a series of flat panels with beads and indentations, surrounds the opening to the firebox. The firebox has been reworked, similar to room 205, however, this firebox displays the most authentic interior brick, as it is aged and carbon stained (Fig. 4-205). The face of the firebox is made of horizontally coursed, stacked bricks. The inside of the firebox is coursed with running bond; a metal lintel runs along the top of the opening (Fig. 4-205). The hearth and wood transition strip match that of the fireplace in room 206 (Fig. 4-205).

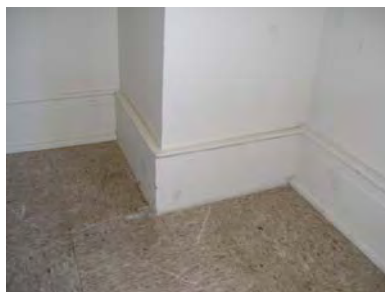
**Fig. 4-210:** Room 210, chase wall in northwest corner. (GWWO photo, 2005.)

This room was originally part of room 209, before the addition of the wall during Period Three. There is a chase wall (Period Five) on the northwest corner of the room that was installed to accommodate HVAC systems. This room has been used as a bathroom in its past history, but has most recently been converted to storage.

to create a bathroom (with modifications through Period Five). The chase wall (Fig. 4-210) in the northwest corner is from Period Five.

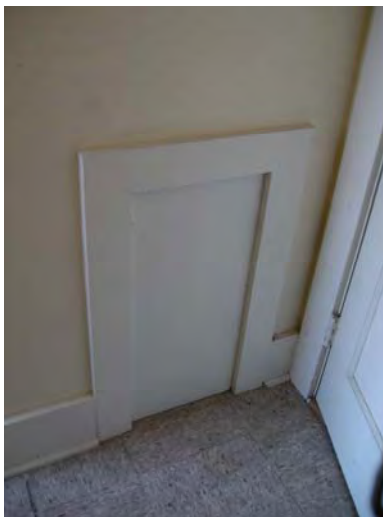
**Fig. 4-213:** Access panel for enclosed tub. (GWWO photo, 2005.)

There is a small radiator (Period Four) below the window on the north wall that is painted white. There is an access panel (Fig. 4-213) on the east wall that surrounds the tub next to door 39 that is framed in simple mitered boards and painted white.

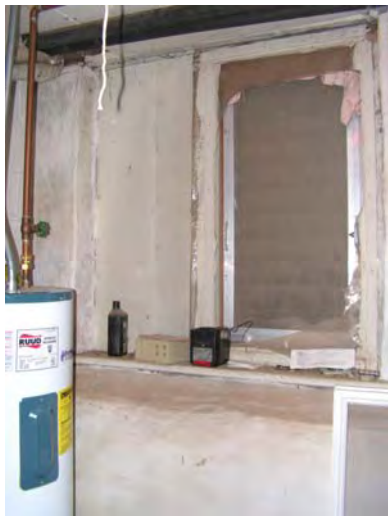
**Fig. 4-223:** Former window 3, north wall. (GWWO photo, 2005.)

***Window 3:*** This opening (Period One) is partially enclosed with plywood toward the south. The northern third of the window has an inoperable, louvered vent (Period Unknown, Fig. 4-223). It is unknown if the sash remains behind the closure.

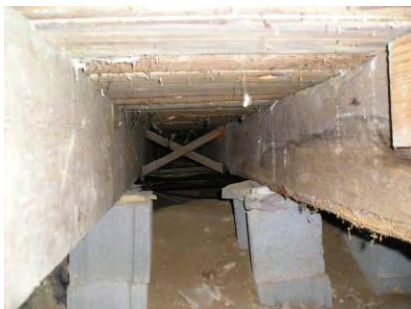
**Fig. 4-232:** First Floor framing at Room 107, below original pantry area. (GWWO photo, 2005.)

The first floor joists were inspected through a very limited exposed ceiling above the furnace room and an approximately 4" x 5" hole at the dining room floor (Fig. 4-232). The first floor structure above the furnace room and at the dining room is dimensional 2" x 9" sawn lumber joists spanning in east-west direction above the furnace room and north-south direction at the dining room. These joists are spaced at 16" to 18" on centers and are supported on a masonry walls. The floor structure was inaccessible for direct view. The photographs were taken by lowering a camera through the floor hole at the dining room. These photographs revealed stacked concrete

masonry units from grade to the underside of floor joists, approximately near mid span.

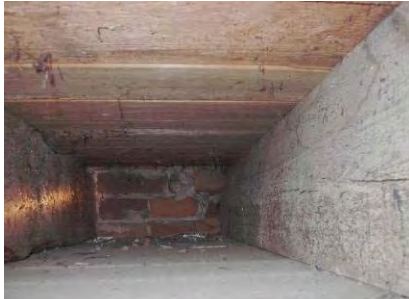
**Fig. 4-233:** Second floor framing above room 107, above area near original pantry. (GWWO photo, 2005.)

The second floor structure above the first floor dining room, room 107, is dimensional 2½" x 9" sawn lumber joists, spanning in north-south direction, are spaced at 16" on centers with a wood plank deck. These joists bear on an exterior brick wall (Fig. 4-233). Two steel "I" beams, with 4-1/2" wide flanges and 12" high webs, are a recent (Period Four) insertion. These beams align with the location of earlier walls that defined the pantry area and stair.

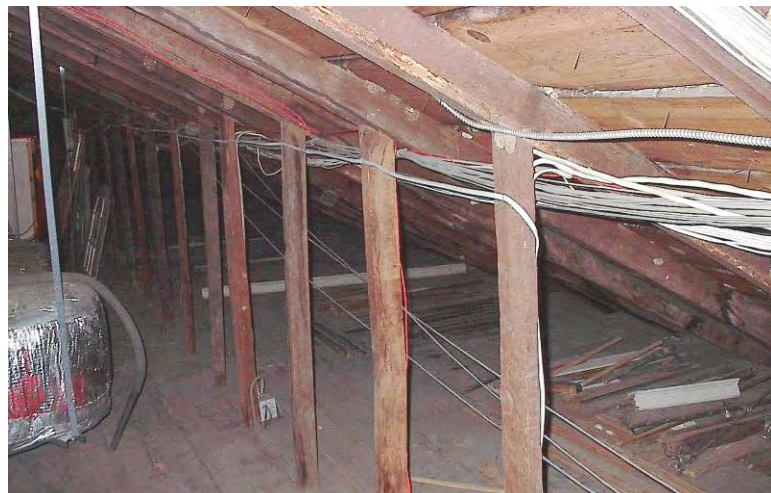
**Fig. 4-236:** Interior post supports at roof rafters, typical. (GWWO photo, 2005.)

intermediate posts, located approximately at one-fourth of the span (Fig. 4-236). These posts are made of irregular shapes, ranging from 1x3 boards to 4x4 posts and are connected to the rafters using iron nails. It appears that these posts were not part of the original construction but added at a later date. They may have been introduced when the roofing material changed from wood shingle to slate (later Period One alteration), due to the added roof loads associated with the slate material. Several of these posts are missing.

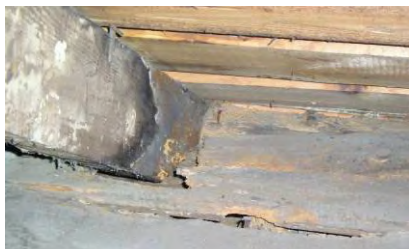
**Fig. 4-238:** Roof rafter and deck deterioration caused by water infiltration at the eave line. (GWWO photo, 2005.)

Approximately 12" from the masonry wall support, rafters have a stepped scarf joint with two wooden nails (Fig. 4-239). Several of these joints are failed (Fig. 4-240). Roof sheathing boards are 1" thick and 6" to 12" wide, nailed to the rafters with a  $\frac{3}{4}$ " to 2" gap—traditionally called sheathing boards—between them (Fig 4-237). Metal roofing is nailed to the roof sheathing boards. Several of the rafters were rotted at their bearings, located on the south side of the west wing, above the porch. Water damage from old roof leaks was observed at these areas (Fig. 4-238). The ceiling above the main east side entrance also exhibited water damage, but the structure was not exposed for inspection.

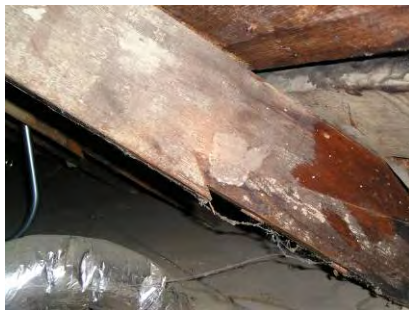
**Fig. 4-239:** Scarf joint at end of roof rafter. (GWWO photo, 2005.)

**Fig. 4-240:** Scarf joint failure condition at end of roof rafter. (GWWO photo, 2005.)

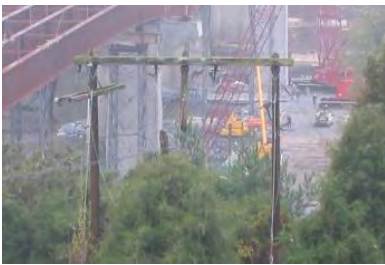
**Fig. 4-261:** Broken support mast. (GWWO photo, 2005.)

Outside to the West of Portico 102, there are overhead utility power lines that are hanging at approximately 5'-6" above grade. There is a broken overhead support mast (Fig. MEP-21) to the North of the site that the power lines connect to before connecting to the utility pole on the site.

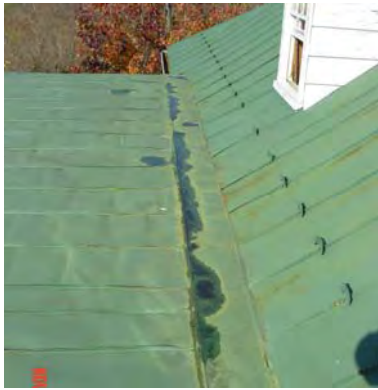
**Fig. 5-001:** View of joint between west block and west porch, looking north. Ponding of water is evident two days after last rain. (GWWO photo, 2005.)

The roof over the west porch appears not to drain effectively (Fig 5-001). Water ponds at the joint between the house and the porch covering, and may be the cause of plaster damage evident on the porch ceiling. The roofing in this area should be removed, the roof framing should be shimmed up to create a more positive slope to prevent the ponding. A supplemental underlayment should be placed in the joint between the two roofs; and a new roof installed over the porch. (Category One, if west porch is to be retained).

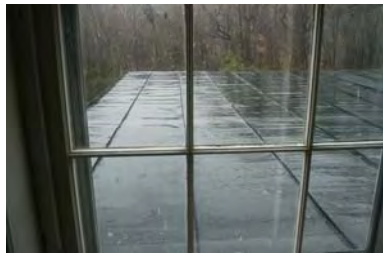
**Fig. 5-002:** Roof over Northeast addition is actively leaking. (GWWO photo, 2005.)

The standing seam metal roof over the northeast addition was put on c1980. At some time after this it was coated with asphalt, perhaps to control leaking (fig. 5-002). Currently this roof is actively leaking with water dripping in the Hall (112) and Meeting (112B) areas. These leaks should be located and patched (Category One).

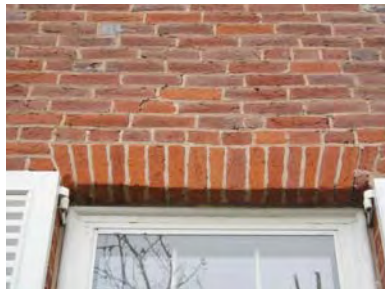
**Fig. 5-006:** Above: Brick jack arch over window 11, west block, north elevation. Cracks over the jack arch have caused the arch to sag in the center. Cracks actually shear bricks in several locations. At right: detail of cracks above the same window. (GWWO photo, 2005.)

A cracked area is located at the west end of the north elevation, between the first and second story windows (below window 36 and above window 11, Fig. 5-006). Cracks located in this region actually shear bricks in several locations. This condition may be the result of problems discussed above on the west elevation. Alternatively, the problem may be due to settlement of the corner of building.

This crack should be treated as discussed above, and the area monitored for at least one-to-two years to see if the movement is progressing (Category One). Once the source of the failure is identified and eliminated, consideration should be given to reconstructing this area of the wall. (Category Two).

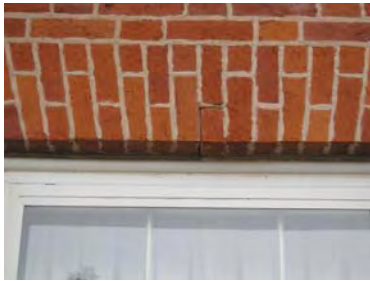
**Fig. 5-007:** Above: Jack arch over window 8, west block, south side, first floor of the west elevation. Joint surrounding keystone brick has cracked, and brick dropped about 1/8". (GWWO photo, 2005.)

There are several miscellaneous masonry problems that currently fall into Category Two. The jack arch over window number 8 on the west elevation is in the earliest state of partial failure, with the keystone brick joint cracking and the brick beginning to drop down approximately 1/8" from its original positions (Figs. 5-007). The arch should be temporarily shored, the brick carefully removed and reset in a new full mortar bed, and the shoring removed.

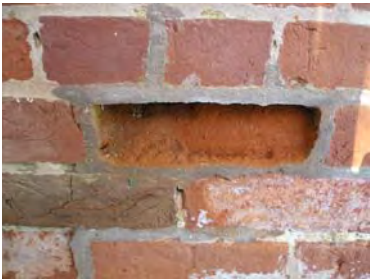
**Fig. 5-009:** Masonry stretcher course immediately below first header course, south elevation, north leg, under south porch, below window 26. One brick has lost the entirety of its surface, and over half of its body, to spalling. (GWWO photo, 2005.)

Two areas of spalling brick were observed. One area is located above the jack arch over window 51, on the east elevation of the west block, second floor (Fig. 5-008). The second area is on the south elevation, under the south porch (Fig. 5-009). In both cases, the spalling is attributable to one of the following causes: the original bricks in question were made from poor clay, the bricks were inadequately fired during their original formation, and/or the surfaces of the bricks were sufficiently destroyed during the sandblasting episode (Period Four) that moisture and the freeze-thaw cycles have destroyed their integrity. The individual bricks should be replaced with new material to match as closely as possible the original in size and color. Currently in the attic there are several stacks of unused brick located near the eave line. These bricks should be checked for size and color for use as possible replacements.

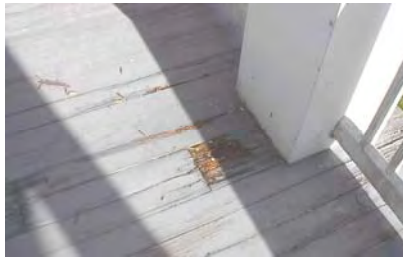
**Fig. 5-012:** View of deteriorated floor decking at south porch. Water has rotted the material. (GWWO photo, 2005.)

At the second floor south porch, the painted wood floor is showing signs of rot (Fig. 5-012). The outer third of the floor should be replaced with new treated wood decking. While the old material is off, the floor joists should be inspected to assess their condition.

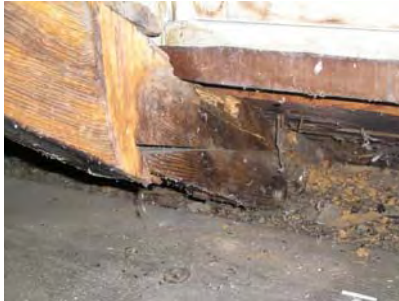
**Fig. 5-014:** Scarf joint failure condition at end of roof rafter. (GWWO photo, 2005.)

At 10 locations, the scarf joints at the end of the roof rafters have opened up. This is, in effect, a failure of the structural member that should be addressed (Category Two). At most of these locations, temporary shims have been placed below the localized failure. The structural engineer has suggested two more permanent options for repairing the failed scarf connections:

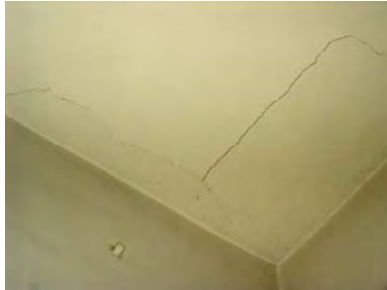
**Fig. 5-016:** Room 101, southwest corner at ceiling, showing sagging plaster that has lost its key to the lath above. (GWWO photo, 2005.)

Severely cracked or bulging plaster, most likely due to the plaster losing its key, is observed in the following areas: Room 101, southwest corner of ceiling, Fig. 5-016, (bulging and cracking of plaster in an area of about 30 square feet); Room 104, north wall above windows 11 and 12, Fig. 5-017, (cracking with some serious bulging over window 12 that extends into the ceiling, total area approximately 60 square feet); and Room 204, north wall above windows 34 and 35 (cracking and bulging, with a total area approximately 40 square feet). The urgency for treatment is Category One, following resolution of the root causes.

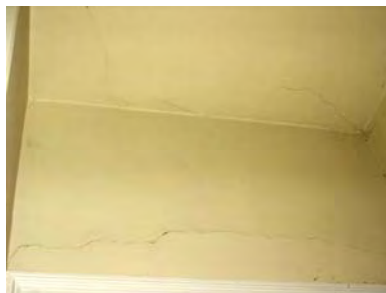
**Fig. 5-017:** Room 104, north wall and ceiling above window 12, showing plaster that has lost its key. (GWWO photo, 2005.)

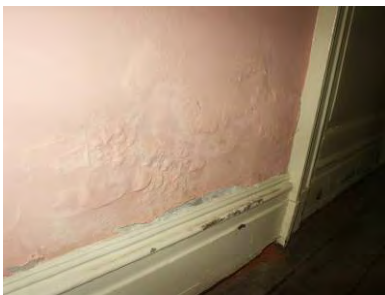
**Fig. 5-019:** Room 107, south wall, showing spalling plaster due to moisture damage. (GWWO photo, 2005.)

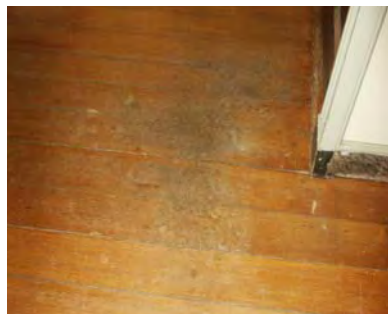
**Fig. 5-021:** Entrance Hall 103, outside basement door 7, showing discolored wood floor area. (GWWO photo, 2005.)

The exposed wood floor in Entrance Hall 103 in the area in front of the basement door 7, Fig. 5-021, is highly worn and darkened. This may in part be the result of a water stain, because the area is so discolored. The area should be locally treated by a wood conservator to remove the dark tones and blend the area in with the surrounding floor finish color.

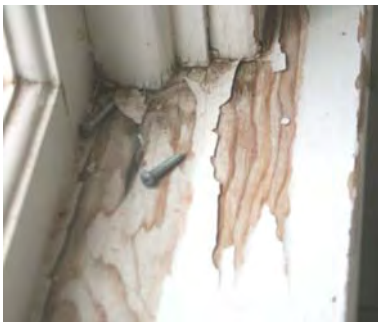
**Fig. 5-025:** Window 28, west side sill, showing peeling paint due to moisture exposure. (GWWO photo, 2005.)

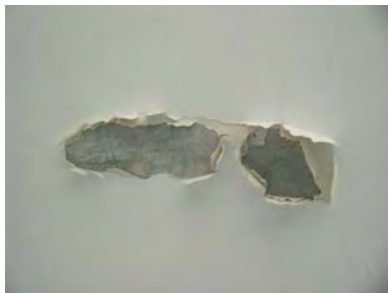
**Fig. 5-027:** Entry 106, showing finish damage at ceiling. (GWWO photo, 2005.)
